**Report on the
Investigation of the
Downers Grove Substation Fire**

The Staff of the Illinois Commerce Commission

December 16, 2005

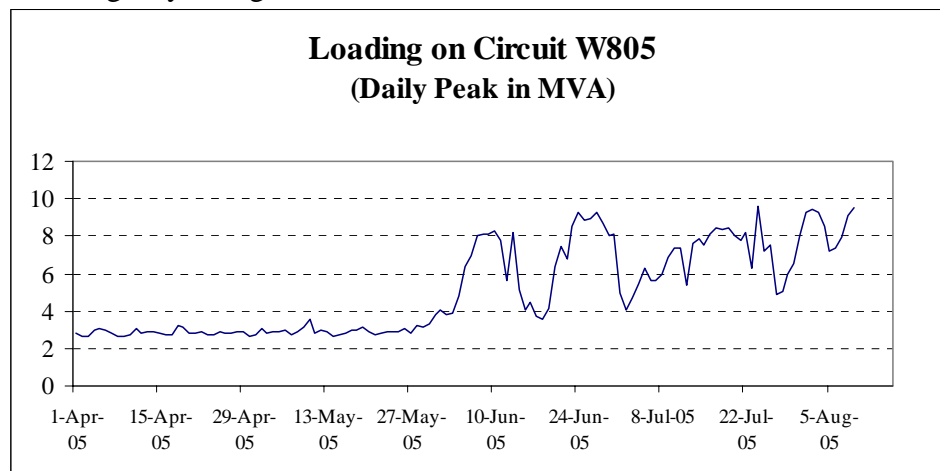
Circuit W805 had been heavily loaded numerous times before the fault. On May 29, 2005, a fault occurred on Circuit W640, which the Woodridge substation normally feeds. ComEd transferred the W640 load to Downers Grove circuit W805.⁶⁴ ComEd repaired the W640 substation exit cable on June 29, June 30, and August 5. In each case, the cable failed the high potential tests and ComEd could not energize it.⁶⁵ Because of these multiple faults, ComEd replaced the W640 exit cable but did not return it to service until September 12, 2005, more than a month after the Downers Grove fire. From May 29 to August 10, 2005, the loading on W805, phase C, exceeded its normal rating on 19 occasions, for an accumulated time of 128 hours since May 29.⁶⁶ The loading on W805 never exceeded the cable's emergency rating. ComEd reported that the priority level to repair W640 changed several times during the time when W805 carried its load.⁶⁷ Operators at the OCC monitor feeder loading via the SCADA system, and engineering and planning are able to analyze feeder-loading history using ComEd's PI-Historian program. However, ComEd did not have guidelines for identifying, notifying, and prioritizing actions needed to relieve feeder loading for ComEd's operations, engineering, and construction departments. Although the overloading may have not caused a properly crimped connector to fail, the bad connector may not have failed if ComEd had not exceeded the cable rating for 128 hours.⁶⁸

The chart below shows the W805 loading prior to August 10.⁶⁹ The normal rating is about 7.9 MVA and the emergency rating is about 11.2 MVA.

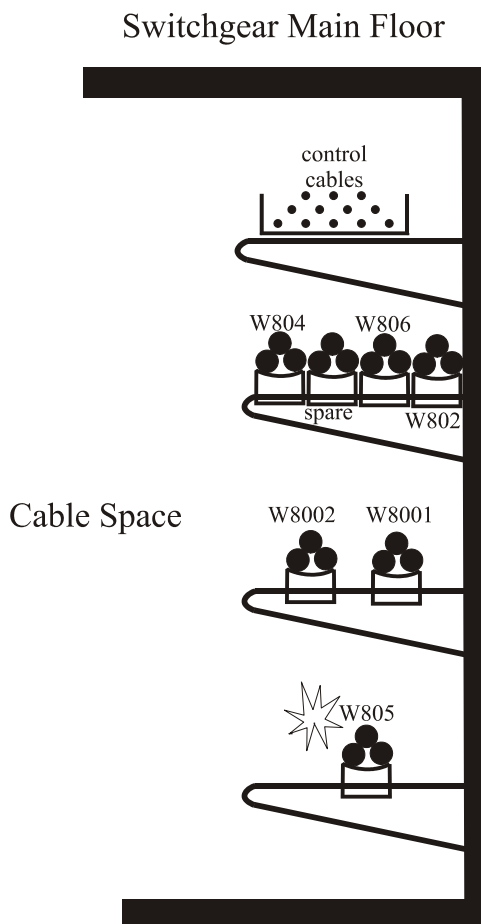
After the jacket on feeder W805 cable joint ignited, the fire spread to other feeder cables, control cables, the Bus 5 switchgear, and eventually started a secondary fire that destroyed the station battery. The diagram below shows the layout of the cables near the faulted joint.

Flame from the initial fire ignited cables just above it. One of these cables (W8002) was the only cable involved that was a cross-linked polyethylene (XLPE) insulated cable.⁸⁰ The polyethylene insulation fueled the fire, along with polyethylene cable jackets on the ethylene propylene rubber (EPR) cables. When additional cables faulted, the resulting arcing fed the fire and increased the temperature at the top of the confined space. The fire burned the control cable pan just above the fire, the insulation of the cables in the pan, and the insulation of exposed battery leads. The battery leads shorted and burned apart. At 4:39 p.m., ComEd lost SCADA power.

As the fire spread among the cables, cable jackets and insulation fed the fire. Arcing occurred as each cable failed, burning up to several feet of copper shield conductors on each faulted cable, intensifying the flames and heat in the southeast corner of the cable space. The intense flame and heat burned away a section of the control cable pan and burned the control cables. The fire burned and shorted the battery bank leads, which ComEd routed in to then out of the switchgear floor above. Conductive vaporized metal and combustion gases traveled along the ceiling and vented up through an open cable penetration where circuit W8020 connects to the metal clad switchgear, burning the cables cleanly off at the terminal points, and causing the feeder cable bus bars to arc to metal cabinet parts.

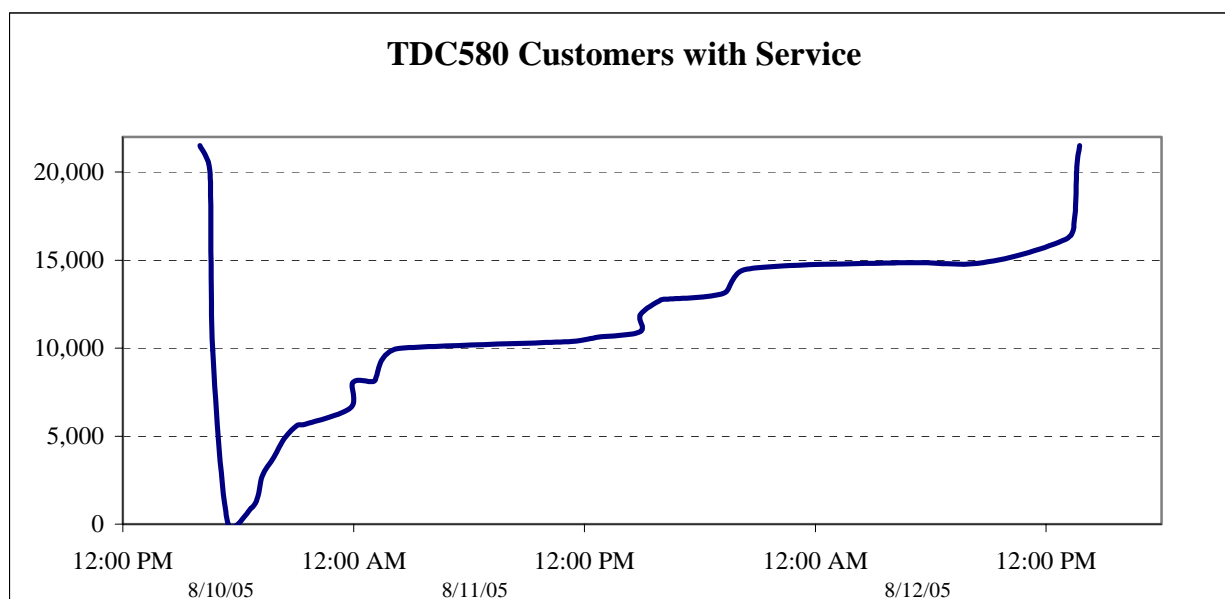
G1. A direct cause of the lengthy outages of some feeders was ComEd's inability to transfer all Downers Grove loads to other substations.

ComEd first restored the feeders that it could easily transfer. During the first 12 hours, ComEd restored about 46 percent of the customers by transfers using external ties. During the second 12 hours, restoration slowed because transfers to other substations were either difficult, or not possible. By 24 hours, ComEd had restored only 59 percent of the Downers Grove customers. During the third 12-hour period, ComEd transferred only one additional feeder and part of another. After 36 hours, ComEd had restored 69 percent of the customers. No additional feeder transfers occurred. ComEd restored the remaining 31 percent after about 44 hours, and only because it re-energized Bus 3 at Downers Grove. The diagram below shows customer restoration over time.
